Two unusual cofferdams

R. H. Keays¹, D. Loidl²

1. Introduction

This paper describes two cofferdams used for protection of works during modifications to existing dam outlet works. The arrangement and details of the two cofferdams have special features that the authors consider of interest to structural engineers.

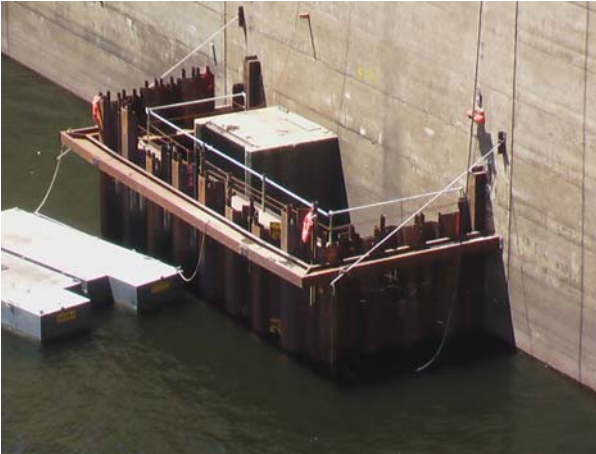
Tantangara Dam was constructed between 1958 and 1960 as part of the Snowy Mountains Scheme in NSW. It is a concrete gravity dam with a capacity of 245GL, located in the headwaters of the Murrumbidgee River. It is used to impound water for diversion to Eucumbene Dam. There is a need to send more water down the Murrumbidgee to provide more flow downstream, and possibly provide an additional source of water for Canberra. To do this required modifications to the outlet works at the dam face. This entailed works at levels significantly below the minimum operating level, and SnowyHydro Authority had allowed for the water to be pumped down to the base of the dam. This would have required drawing down the water to 15m below the minimum outlet level. Geotechnical Engineering bid for the works, with an offer of an alternative which did not require nearly as much draining of the dam or any requirement for pumping. The client accepted this offer.

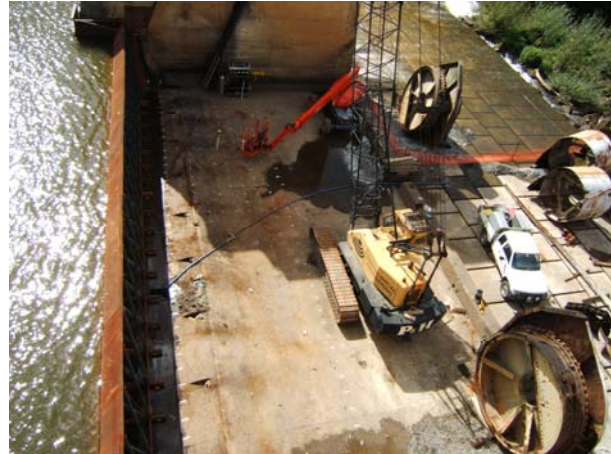
Yallourn Weir

The Yallourn Barrel Weir was constructed in the 1920s to form a weir pool in the Latrobe River from which water supply could be extracted to meet the requirements of the power stations. It has a concrete sill structure with a fixed crest and an adjacent drum gate. Part of the upgrade work carried out by Geotechnical Engineering in 2005-6 was to replace this gate by a further section of fixed crest and to install a small diversion outlet in the new crest.

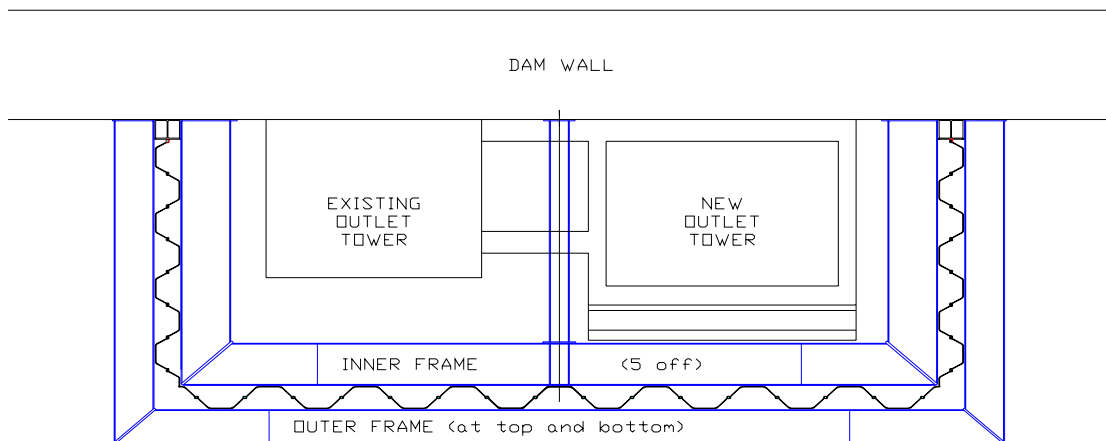
Figure 1 Plan view of Cofferdam

The method offered was to construct a cofferdam using sheet piles, with framing to support the piles off the upstream face of the dam wall. This allowed the majority of the new outlet works to be completed in the dry. The new permanent works are another outlet tower, with screens and gates for selective drawing of water from different levels in the dam. This outlet tower is connected to the original tower by a short tunnel, as shown in Figure 1.

The sheet pile wall of the cofferdam was about 12.5m long by 5.3m wide. This was sufficient to enclose both the existing outlet tower and the new tower set 2m to one side.

The top of the cofferdam was set at 1m above the average operational level of the operating dam. At the bottom, the base rock sloped steeply along the dam face. The longest sheet pile was 17.4m and the shortest 12.4m. The base of the outlet tower is on a mass concrete footing bearing on the rock upstream of the dam face. The sheet piles served as formwork for the mass concrete. There was about 150m³ of concrete in the mass footing, made in one pour using a tremie pipe.

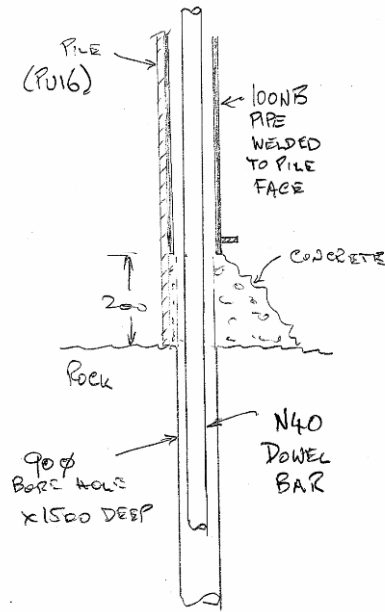
Figure 2 Dowel bar at base of sheet pile

Two dowel bars were provided on each PU16 sheet pile with a cantilever greater than 2.5m, and one on the remainder. The construction process was:

- Using the 100NB pipe, deliver blinding concrete to base of pile.
- Bore a 90 diameter hole through this concrete and into the rock.
- Place N40 dowel bar and grout.

From the designer's perspective this appeared complex, but to Geotechnical Engineering, as an experienced drilling contractor, this was the best way to achieve the dual aims of securing the dowel and providing some sealing on the inside of the sheet pile wall for the later mass concrete pour.

The detail worked. The base of the sheet pile wall was secured, and there was no significant loss of concrete.

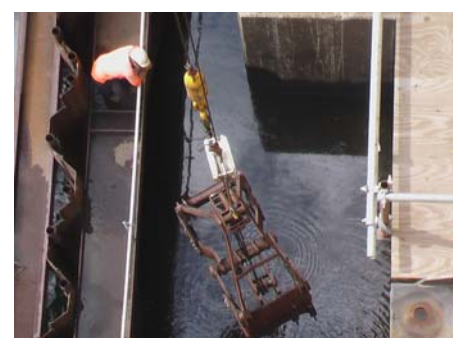
With a dam that had been filled for over 40 years, there was a considerable accumulation of rotting vegetation and silt at the base of the dam wall. It was necessary to remove this carefully, minimising the extent of contamination of the relatively clean water stored above. The sheet pile wall provided a barrier to contain the vegetation during mucking-out. There was a surprising amount of debris,

mainly weed and grasses, sufficient to impede the progress of placing the sheet piles. The clean-up was completed using divers to jet-blast the exposed rock in preparation for the mass concrete pour.

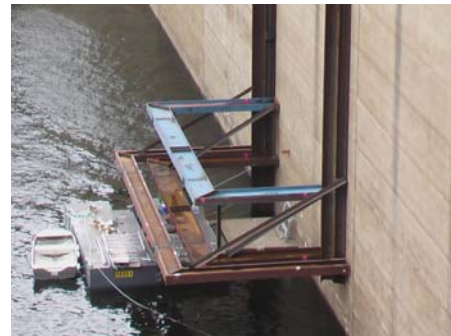
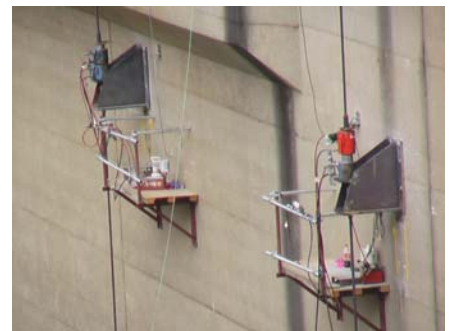
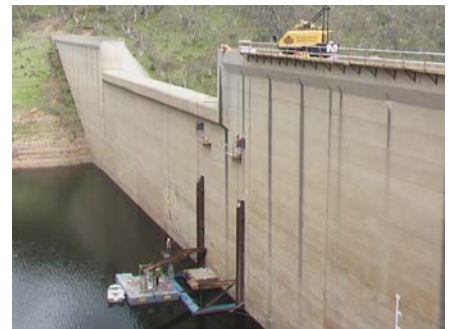
The complete frame assembly (about 35t) was assembled above the water, supported by two VSL bars. Jacks were used to lower the frame into the water as successive frames were added on top of the previous construction.

It was noted above that the internal frames were propped at mid-span. The second lowest props passed through the horizontal tunnel from the new outlet tower to the existing outlet tower and thence to the downstream works. The designer intended that these props would be “lost”. At completion of the construction works, the dam level was down about 3m below the design level, so the question was asked whether the props could be removed prior to flooding the inside of the cofferdam. The checks showed that a plastic hinge would form at the corners, but the extent of deformation would be limited by the ability of the sheet piles to transfer load to the frames above and below. The prop was then removed, and nothing untoward happened.

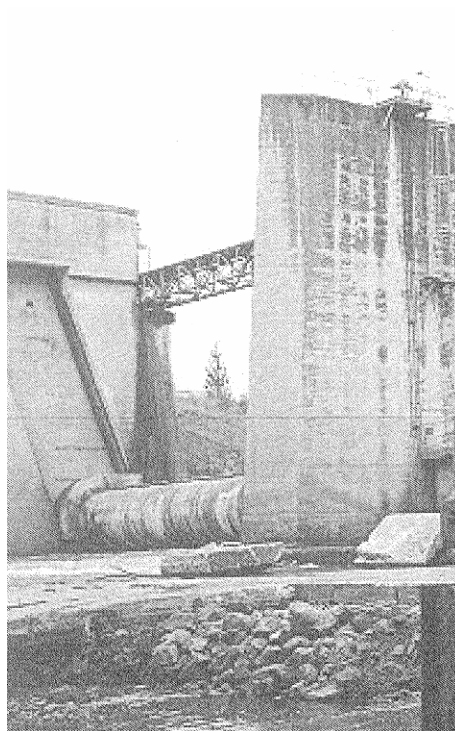
Figure 3 View of drum gate from downstream

The drum gate (shown in Figure 3, below) was a 2.74m diameter, 30m long cylinder constructed of riveted steel plates. Each end of the drum was fitted with a large pinion which engaged with racks set into the concrete piers. It provided a means for accurately controlling the level of water in the pond.

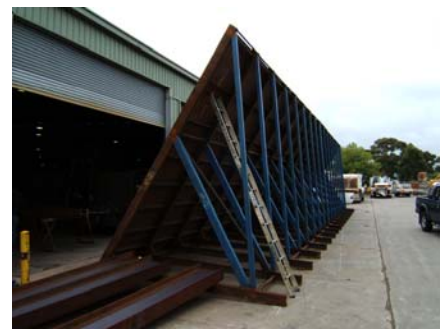
After award, the design concept was developed further, increasing the freeboard to the required 1m. End sections interfacing to the curved ends of the piers were detailed, and bracing provided to provide a positive restraint to the inclined struts and floor joists. It was decided that the cofferdam structure would be built in sections in the workshop with simple field-bolted seams between sections.

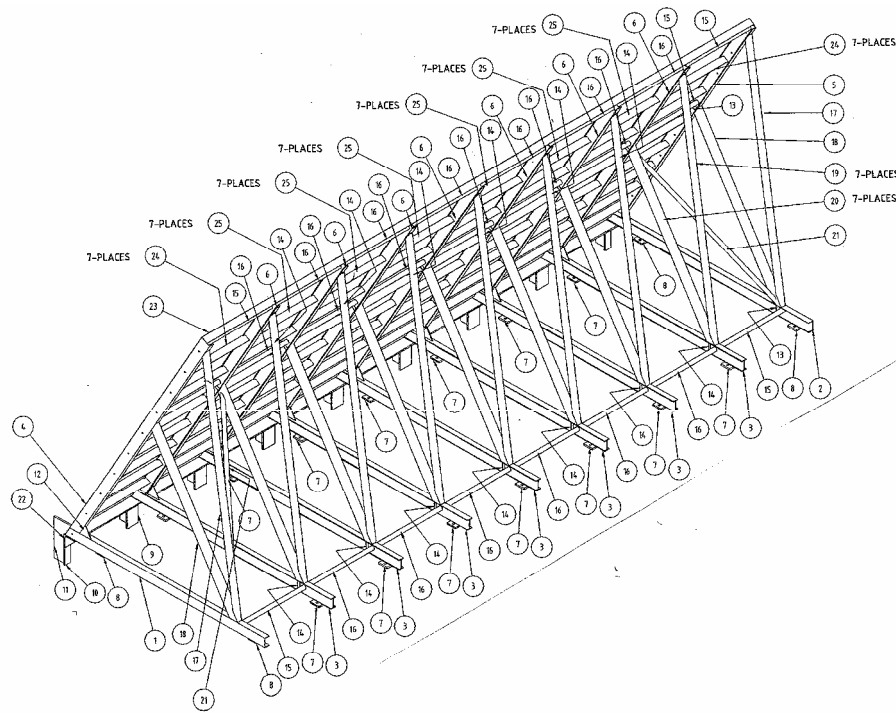
Figure 6 Isometric view of section of cofferdam

The design was reassessed assuming overtopping about 3m above the crest (2m above the cofferdam). The major change was to add another strut to support the cantilever end of the wall joists, which served to strengthen the joist, and provide guidance to any debris which might come over the top of dam. With the additional water pressure, the line of action shown on Figure 2 rose above the back of the floor joist, requiring tie-downs. However, it remained that the dam could be dewatered without these tie-downs, allowing them to be installed "in the dry".

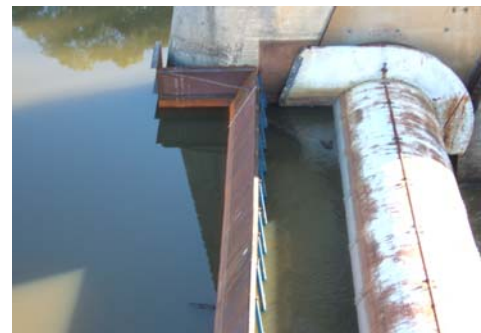
Construction was uneventful, with the structure behaving as expected. The step on the apron was similar to that shown on the drawings, and only a few modifications were required at the ends where the transition to the piers was different.

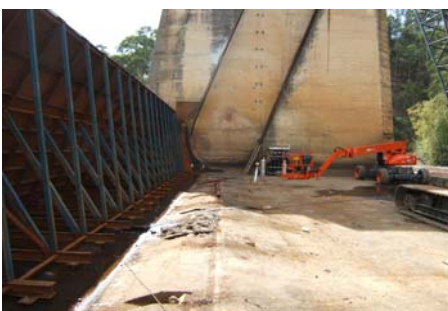
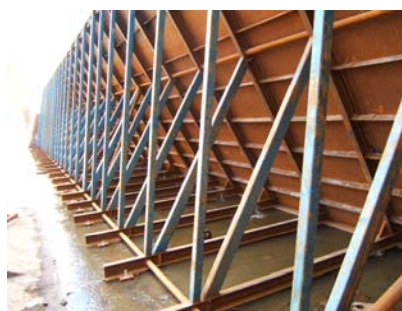
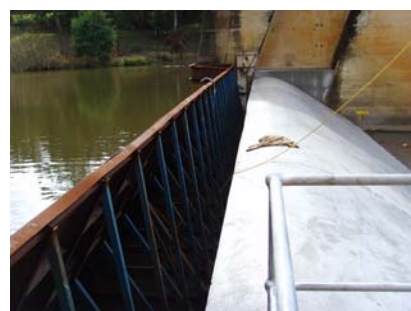
There was just one cause for concern. Towards the end of the construction process, after the new main spillway had been installed, it was found that the few modifications at the end resulted in a clash between the temporary steelwork and the inlets to the new outlet structure at the western side. This clash was as a result of the modification mentioned above. To address this, the design was modified to allow removal of one set of struts, with the pressure loads transferred to the adjacent struts. When the load was transferred to the adjacent struts, one deformed more than one would expect. The cause was identified as the absence of one 50x5 flat web stiffener on the 150UB floor joist (and only on that one joist). This problem was rectified by welding in a new stiffener, and the structure served its remaining few weeks of service without distress.
