SEM ANALYSIS OF CFRP STRAND FOR USE IN HIGH CAPACITY PERMANENT GROUND ANCHORS

Abstract

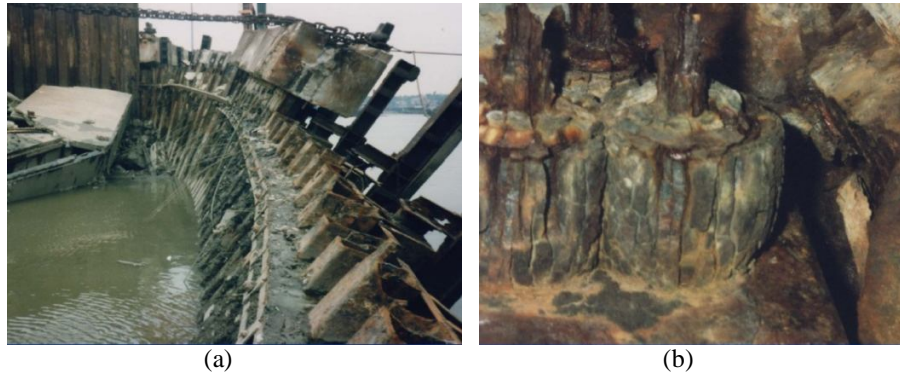
Figure 2: Failure of anchored quay wall (b) corroded barrels and wedges in anchor head (c) lack of corrosion protection behind anchor block [7, 11]

Littlejohn [6] reported on 35 known cases of corrosion related failures to steel tendon ground anchors, concluding that free length corrosion comprised 60% of failures, 34% of failures occurred at the anchorage head and only 6% of failures occurred in the fixed anchor length. Catastrophic structural failures can occur as a direct result of ground anchor failure due to corrosion (Figure 2).

Steel tendon corrosion occurs locally where the tendon intersects a crack in the surrounding grout, or as a result of damage to the corrosion protective sheaths [9]. Grout cracks occur as a result of either shrinkage strains during curing or tensile loading of the anchor. Due to grout micro cracking, majority of standards do not permit grout to be considered as one of the two means for corrosion protection. Weerasinghe and Anson [10] and Mothersille [11] provided project examples where corrosion occurred above and below the anchor head, resulting in anchor strength reduction (Figure 2).

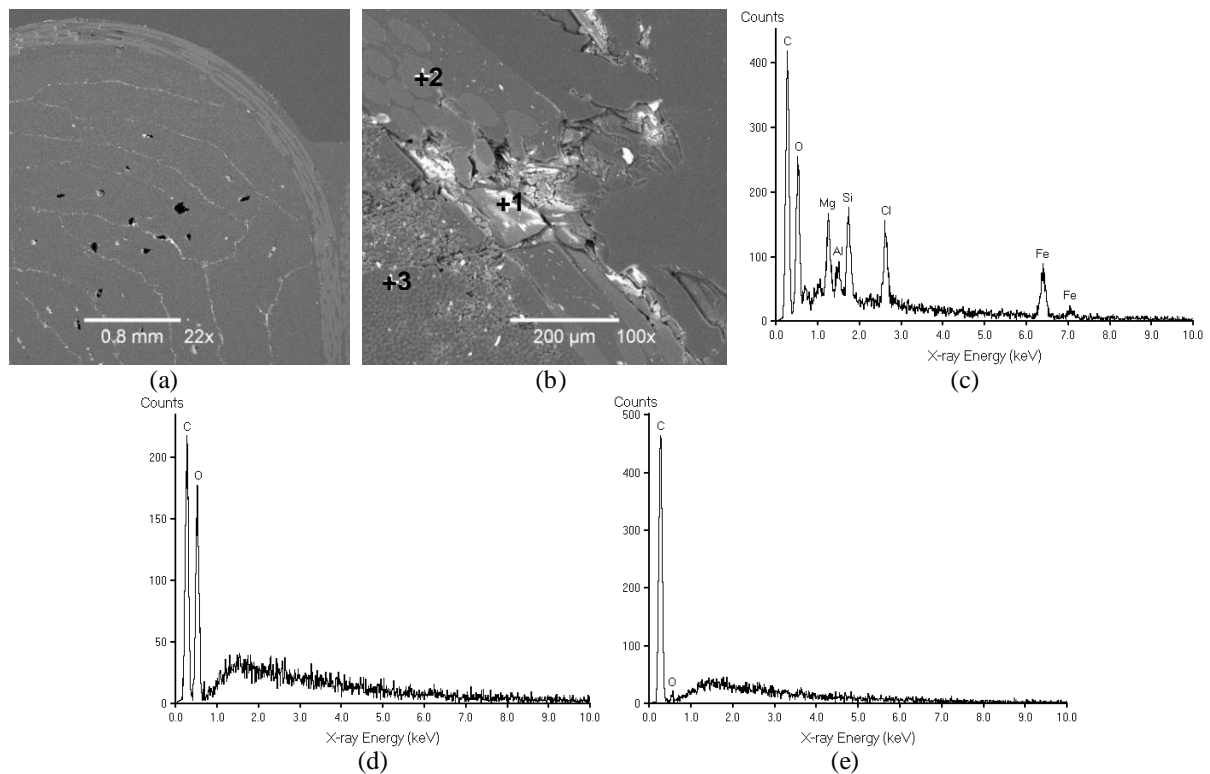
Figure 8: CFCC strand cured at 60°C in alkaline solution (a) 3 month specimen – wire intact; (b) localised are where damage was observed in outer layer; (c) Chemical analysis showing elements imbedded in outer layer (point 1); (d) chemical analysis of intact outer layer fibre (point2); (e) chemical analysis of carbon fibre filament (point 3)

SEM analysis on CFCC specimens exposed to alkaline aggressive groundwater solution did not show any global signs of deterioration over a six month exposure period at temperatures of 60°C (Figure 8). Figure 8b shows a location of localised outer fibre layer damage. Three points were analysed including the different sections of the outer layer and the inner carbon fibres. The graphical results for the three points are also represented in Figure 8. Figure 8c shows composition analysis of the specimen at the point where damage to the outer layer was observed. The composition analysis identified chloride, silicone and magnesium present. These are minerals found within the aggressive alkaline ground solution. The iron and aluminum present may be a result of the cutting tools used in specimen preparation. Composition analysis of the outer layer away from the damaged section (Figure 8d) identified only carbon and oxygen; indicating the minerals observed in Figure 8b are that of the aggressive solution. Composition analysis of the carbon fibres located near the damaged section of the CFCC specimens (Figure 8e) identifies only carbon present. This concludes that there was no chemical attack on the carbon fibres due to the break in the outer layer.
